AFWAL-TR-85-2097

IMPROVEMENT OF THE CORROSION RESISTANCE OF TURBINE ENGINE BEARINGS

April 1986

Final Report for Period August 1981 - August 1985

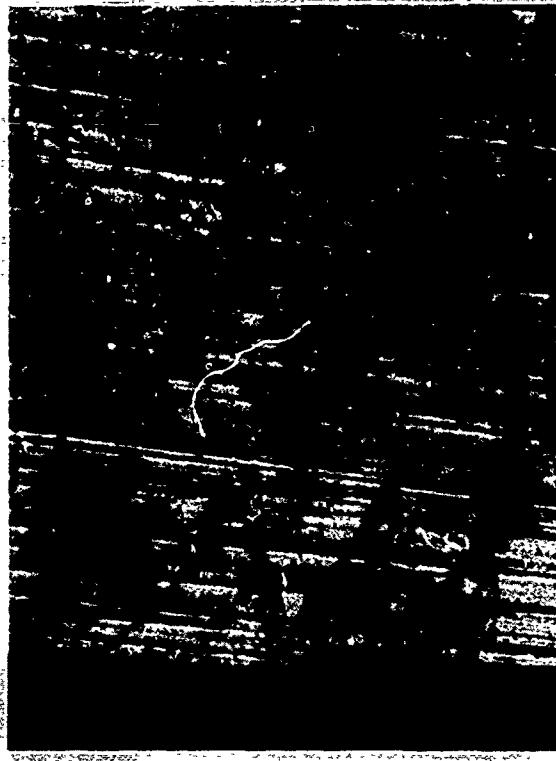
FD 230889

Corrosion corresponding to slightly darker stains of the M50 material (mainshaft bearing C) which was amenable to SEM and XES analyses, appeared to follow the grain boundary morphology (Figure 15). Localized stress concentration in the lattice structure along the grain boundary, i.e., grain boundary energy, rather than transgranular differences of chemistry, is believed to be a primary mechanism responsible for initiating autocatalytic pitting corrosion along grain boundaries in the storage environment.

Figure 15. — SEM Photomicrographs and XES Spectra of Lightly Stained M50 Bearing Material (Main Shaft Bearing C) Which Appears to Follow the Grain Boundary Morphology (Arrows)

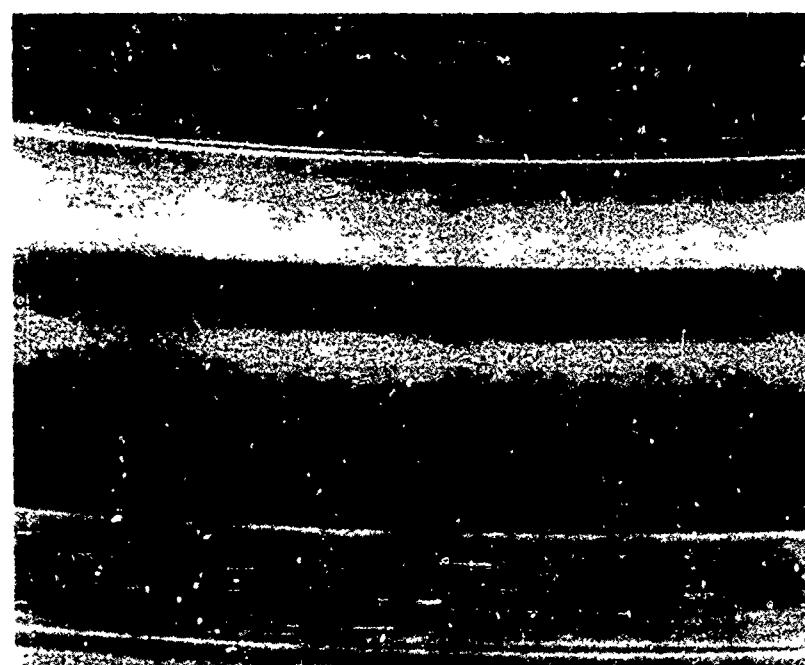
FD 230890

Corrosive attack of M50 and BOWER 315 steel rolling elements and races of service bearings was less evident than that of stored bearings (Figure 17). Staining of the alloy surface was not encountered. Rather, the morphology of the corrosive attack of these bearing components was confined to almost microscopic pitting which, though widespread, was difficult to see except at higher magnification (Figures 18 and 19).

Pitting Attack of Ball

Pitting Attack of Outer Race

Figure 18. — Pitting Attack of Functional Surfaces of Service-Rejected Bearing (Main Shaft Bearing J, Service in MIL-L-7808 Oil)

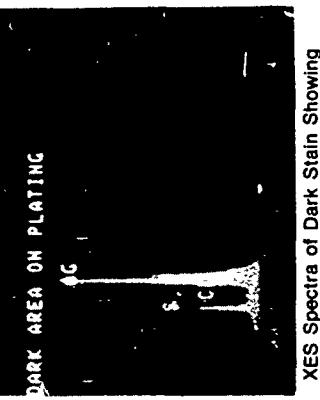
FD 235804

XES Spectra of Dark Stain Showing High Sulfur Content

XES Spectra of Location Shown Above. Note Lower Intensity in Region of Spall

Figure 24. — SEM Photomicrographs and XES Spectra of Thin, Dark Stains of Silver-Plated AISI 4340 Steel Showing Mudcracked Morphology and High Sulfur Content in Locations of Corrosive Attack (Accessory Bearing H)

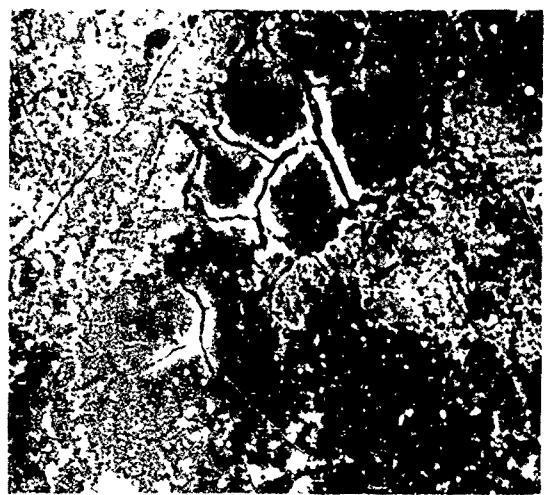
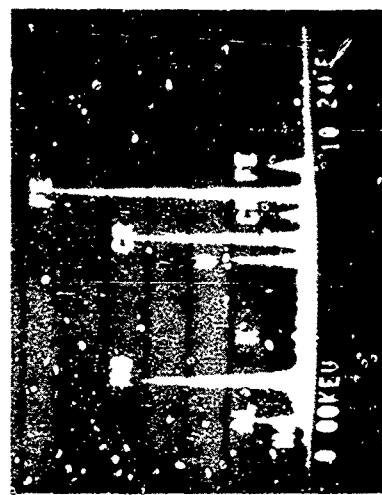
FD 308365

XES Spectra of Mudcracked Region.
Compare Spectra of M-50 Base Material

Figure 27 — SEM Photomicrographs, XES Spectra, and X-ray Maps of Mudcracked Region of Figure 26 Showing Relative Enrichment of Alloying Elements Due to Leaching Away of Iron Corrosion Products

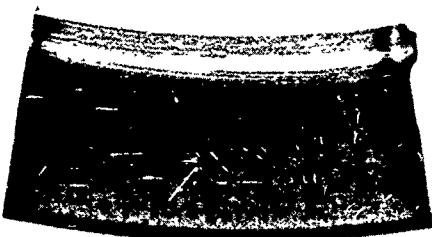
The M50 steel and silver plated pairs were also tested by immersion in dry mineral oil solutions containing tritylthiol (triphenylmethyl mercaptan) at 0.0100, 0.0020, and 0.005 percent weight sulfur concentrations and solutions containing trityl chloride (chlorotriphenylmethane, triphenylmethyl chloride) at the same levels of chloride concentration. Samples were again placed in an oven at 140°F for 24 hours. Results indicated that the silver plate was the most susceptible material to attack by both chloride ions and reactive sulfur down to the lowest concentrations tested, with sulfur producing the heaviest stains. The M50 steel was unaffected by the reactive sulfur and all but the highest concentrations of chloride ions (Figures 34 through 39).

Figure 35. — Specimens (M50 Steel at Bottom, Silver-Plated Coupon at Top) Exposed to 0.0020 Percent Weight Sulfur (as Trityl Thiol) in Mineral Oil at 140°F for 24 Hours

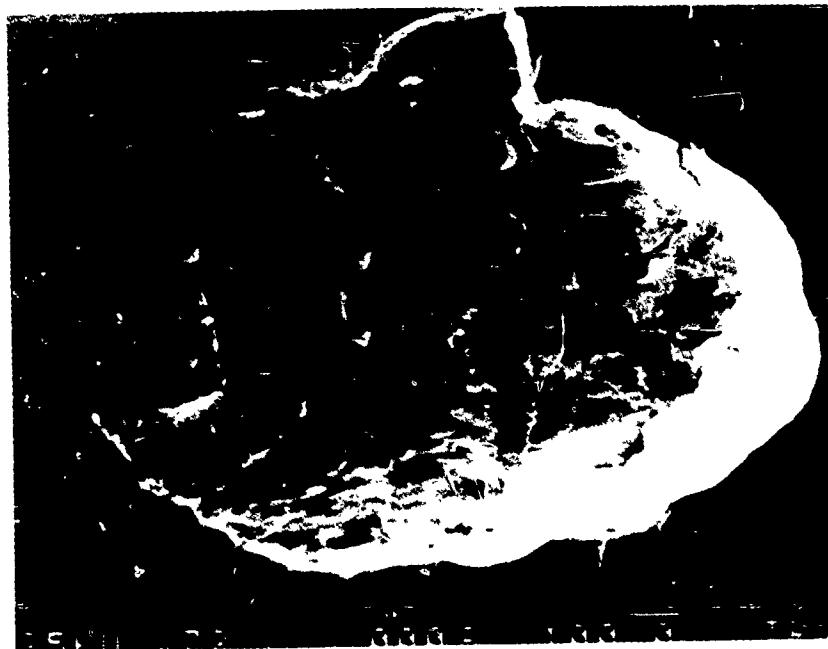
Figure 72 — SEM View of Spall in Chrome-Plated Test Bar HA-1
(Magnification 72 \times)

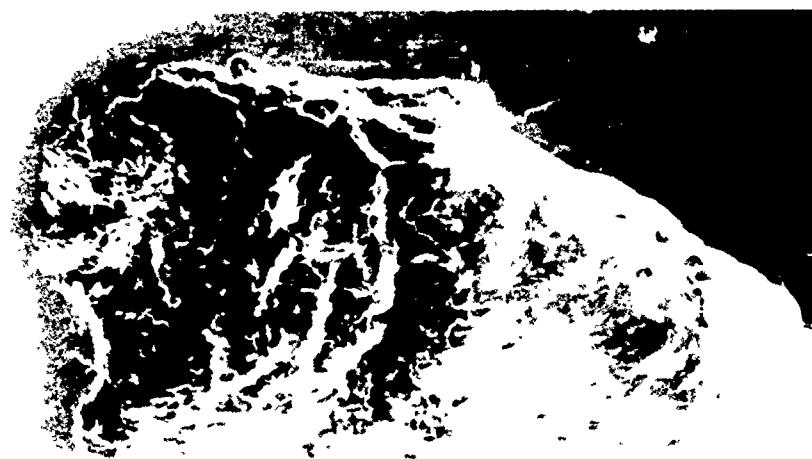
Figure 74. — SEM View of Spall in RSR565 Test Bar HR-1 (Magnification: 72 \times)

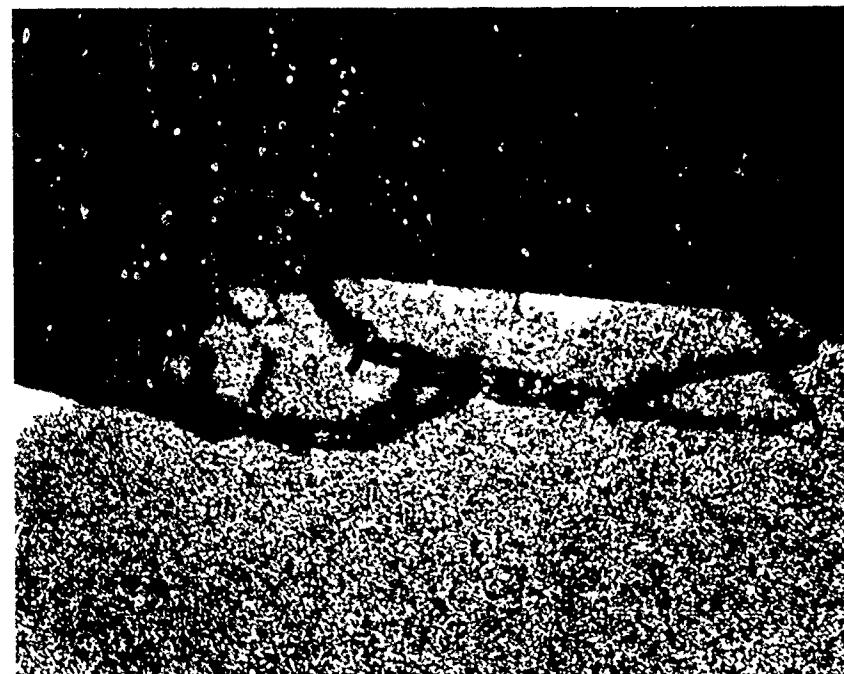
Inner Race Spall (20X)

E20 Inner Race Spall Cross Section (100X)

Figure 110. — MRC2001 35-mm Endurance Bearing S/N E20 Spalled Inner Race

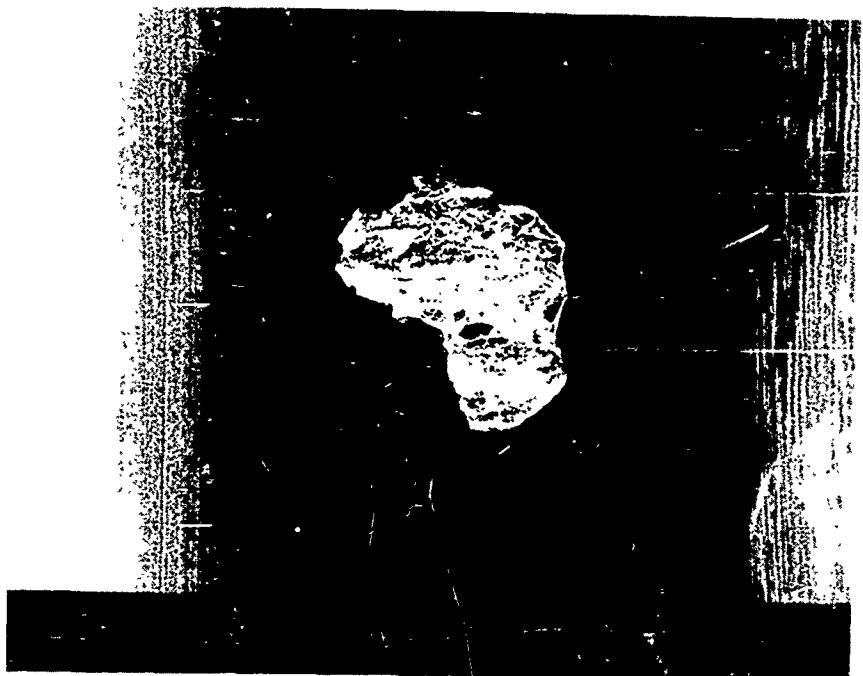
Figure 111. — MRC2001 35-mm Endurance Bearing S/N E12 Outer Race Spall (20 \times)

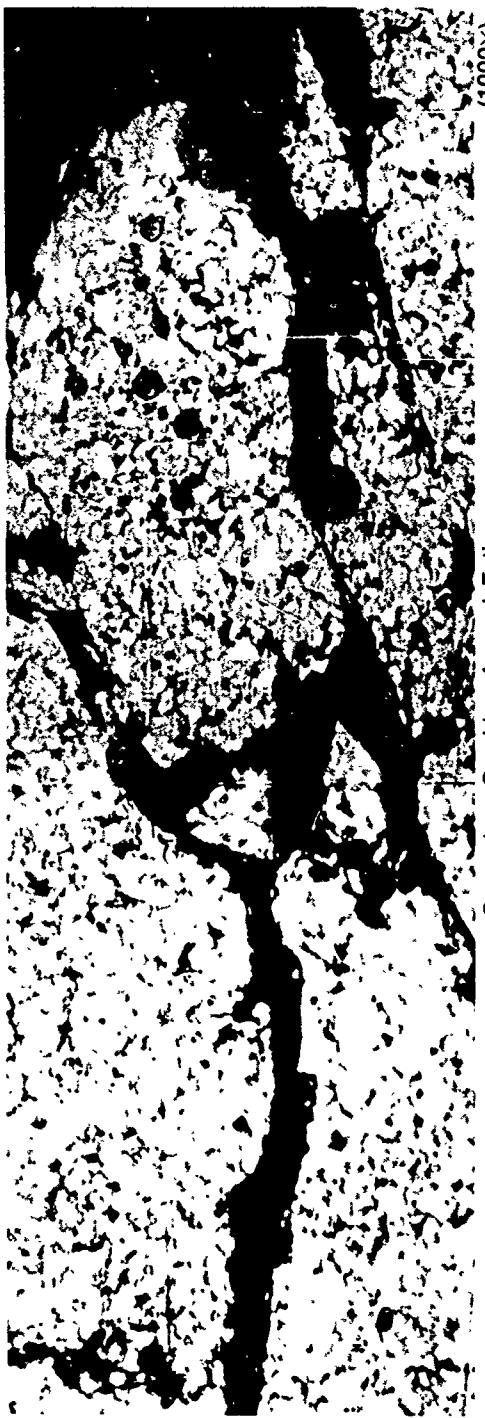
Secondary cracks adjacent to the primary bearing fatigue spall followed prior austenite grain boundaries (Figure 114). The cracks only followed a martensite-carbide boundary when a grain boundary was also present. This type of fracture path has been observed in the past for other powder metallurgy high chromium bearing alloys. It was not possible to precisely determine the fracture path of the primary spall on either the RCF bar or the bearing; however, the fracture path for both spalls appeared to also follow the prior austenite grain boundaries. The RCF bars did not exhibit secondary cracking around the primary spall possibly because there was less secondary damage after the spall.

Secondary Cracking Around Fatigue
Spall of 35 mm Bearing Inner Race
Nitrol-Picral Etch
(1000 \times)

MRC2001 Rolling Contact Fatigue
Specimen Spall Nitrol-Picral Etch
(1000 \times)
FD 300518

Figure 114. — Photomicrograph of Primary Fatigue Spall of MRC2001 RCF Specimen and MRC2001 Inner Race

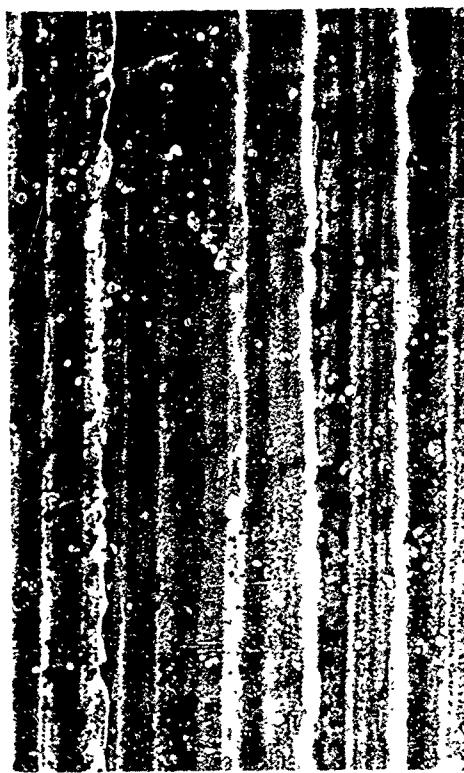
- SEM replications corroborate the differences in finishes observed and measured between inner and outer rings (Figure 123). Grinding furrows are more evident and distinct in the MRC2001 outer rings than in M50 rings, even after hours of running.

Figure 123. — Comparison of Typical MRC2001 and M50 Race Surface (1000X)
FD 300523
